Landshore® Enterprises, LLC

Griffin Lakes Community Development District
c/o: Mr. Angel Camacho, Alvarez Engineers
5385 N. Nob Hill Road,
Sunrise, FL 33351

April 4, 2022

Please allow us to summarize the findings and proposed solutions as described in the Erosion and Sedimentation Control Plan for five (5) lakes located within the Griffin Lakes Community Development District, provided by Landshore Enterprises, LLC (“Landshore®”, “Our”, “We”).

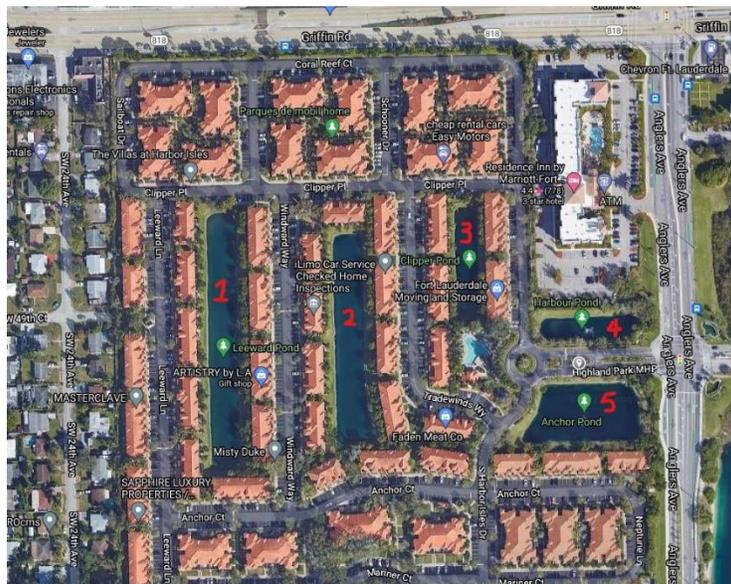
The most common type of lake bank erosion is a stair step type of drop-off or linear erosion. This is the case in the lakes at Griffin Lake CDD, where the water level is normally close to or at control elevation.
